Report on Seismic Damage of Lifts and Escalators by Large Earthquakes in Japan

Satoshi Fujita¹, Motoo Shimoaki² and Keisuke Minagawa³

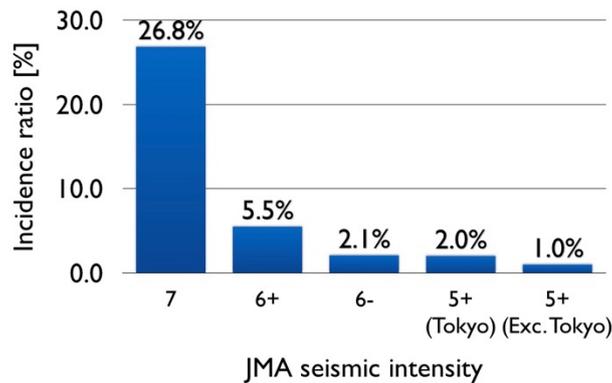
Figure 3 Incidence ratio of lift by Japan Meteorological Agency seismic intensity scale (Great East Japan Earthquake in 2011)

Fig. 3 shows the incidence ratio by the JMA seismic intensity scale. The JMA seismic intensity is defined by Japan Meteorological Agency and is calculated from ground acceleration in consideration of frequency components. The minimum level is 0, and the maximum level is 7. As shown in Fig. 3, more than 1/4 of lifts in area of the JMA seismic intensity 7 were damaged. In addition, the incidence ratio increased when the JMA seismic intensity was more than 6+.

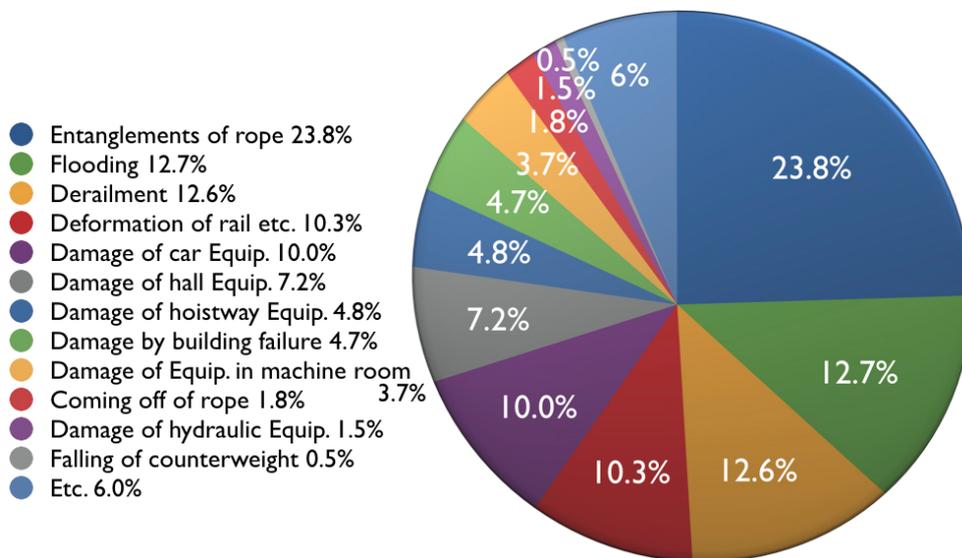
Figure 4 Damage of lift by cause (Great East Japan Earthquake in 2011)

Fig. 4 shows damage of lifts by the cause. As shown in Fig. 4, entanglements of ropes accounted for 1/4 of total damage. The reason was that large areas in Japan including Tokyo where many buildings exist were affected by the earthquake. Vibration of ropes relates to such parameters as the height of a building, the length of a rope, and the ground condition. For example, Tokyo is located on a sedimentary layer, and long period seismic waves are excited by this layer. In general, high-rise buildings and long wire ropes have long natural period, so that there are risks of resonance. Then many damages by flooding also occurred. This is a one of the features of the Great East Japan Earthquake. Other mechanical structures were also damaged by large tsunamis [7]. In addition, a lot of damage that was caused by interaction with buildings such as entanglements of ropes, deformation of rails, and damage of hoistway equipment occurred. Close cooperation with structural engineers of buildings is strongly recommended to reduce the damage of lifts. Falling of counterweight blocks occurred as well as past destructive earthquakes. Although the number of the falling of counterweight blocks was few, it may result in human casualties. However no falling of counterweight blocks in lifts that were designed by applying the Seismic Design Guideline issued in 2009 occurred. Therefore, the guideline was revised effectively.

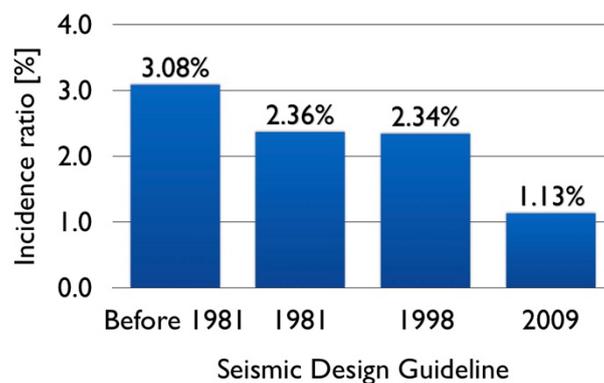
Figure 5 Relationship between edition of Seismic Design Guideline and incidence ratio of lift (Great East Japan Earthquake in 2011)

Fig. 5 shows relationship between edition of the Seismic Design Guideline and the incidence ratio. Since the incidence ratio has decreased with the edition, the revision seems to have been effective.

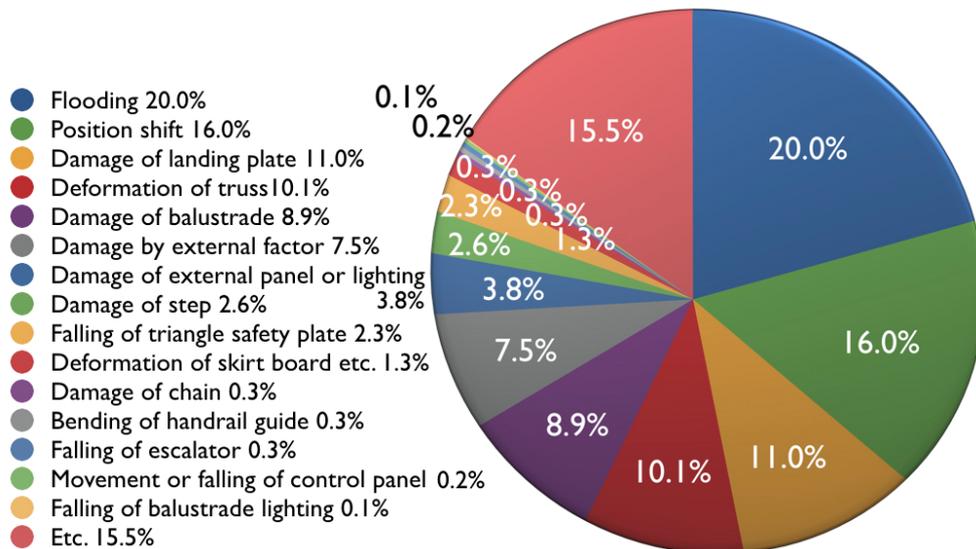
Figure 6 Damage of escalator by cause (Great East Japan Earthquake in 2011)

Figure 6 shows damage of escalators by the cause. As shown in Fig. 6, damage by flooding that is one of the features of the Great East Japan Earthquake accounted for 1/5 of total damage. Apart from that, damage such as position shifts and damage of landing plates occurred. This damage might be caused by interaction between buildings and escalators.

In addition, 4 escalators in shopping malls fell from floors of buildings. Although the number of the falling of escalator was few, it may cause human casualties if passengers are on the escalators. Therefore, a project and revision of the guideline regarding fall accidents were carried out after the earthquake [8].

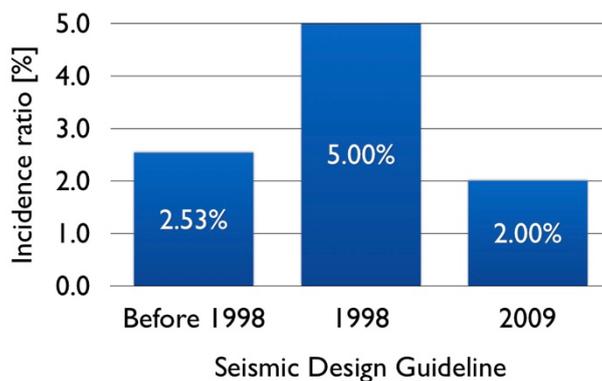
Figure 7 Relationship between edition of Seismic Design Guideline and incidence ratio of escalator (Great East Japan Earthquake in 2011)

Figure 7 shows relationship between the edition of the Seismic Design Guideline and the incidence ratio. The incidence ratio of escalators designed before 1998 was smaller than escalators that were designed by applying the Seismic Design Standard issued in 1998. On the other hand, the ratio of escalators after 2009 decreased.

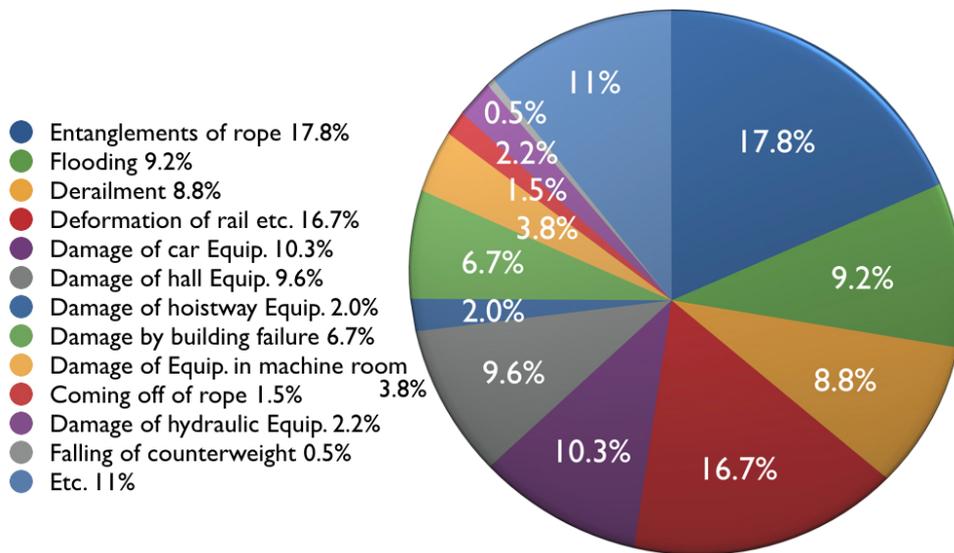
Figure 9 Damage of lift by cause (Kumamoto Earthquake in 2016)

Fig. 9 shows damage of the lifts by the cause. As shown in Fig. 9, damage related to buildings such as entanglements of ropes, damage of rails, cars, halls equipment mainly occurred. The duration time was long and response displacement spectra was high as shows in Fig. 8, so the ground motion caused

the entanglements of ropes. Five cases of falling of counterweight blocks occurred, but these happened at lifts that were designed by applying the Seismic Design Guideline issued in 1981 or before.

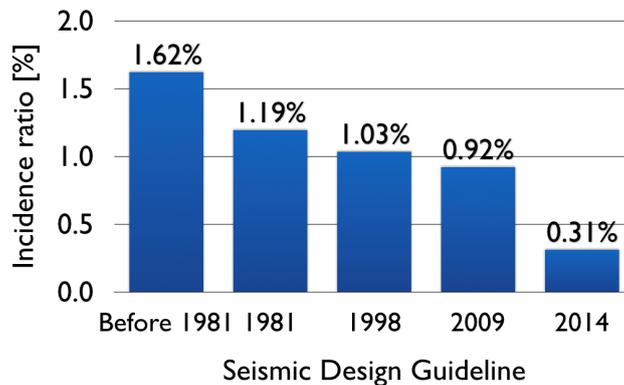
Figure 10 Relationship between edition of Seismic Design Guideline and incidence ratio of lift (Kumamoto Earthquake in 2016)

Fig. 10 shows relationship between the edition of the Seismic Design Guideline and the incidence ratio. Since the incidence ratio decreased with the edition as well as the Great East Japan Earthquake, the revision seems to have been effective.

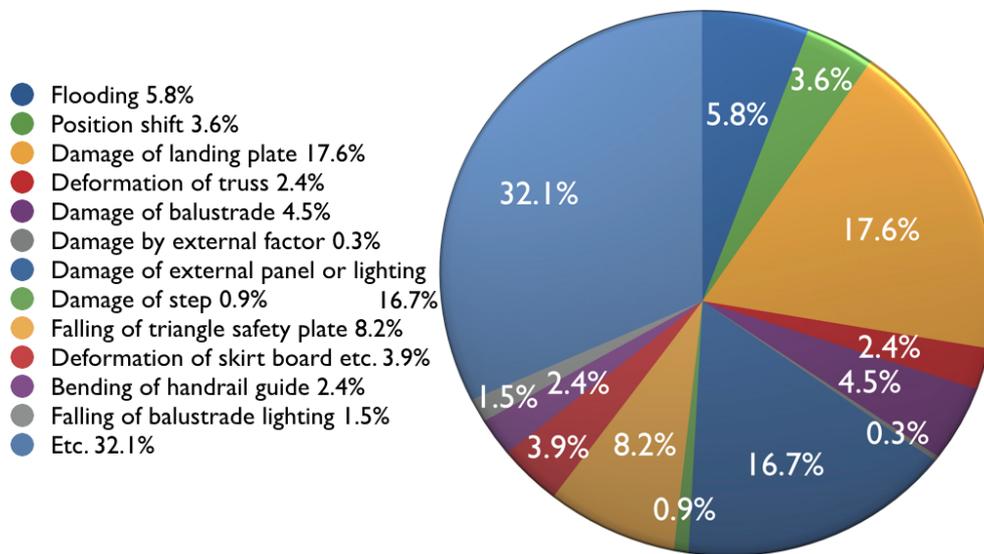
Figure 11 Damage of escalator by cause (Kumamoto Earthquake in 2016)

Fig. 11 shows damage of the escalators by the cause. As shown in Fig. 11, damage mainly occurred in landing plates, external panels or lighting, and this damage was related to interaction with buildings. In addition, no fall accident of escalator occurred.

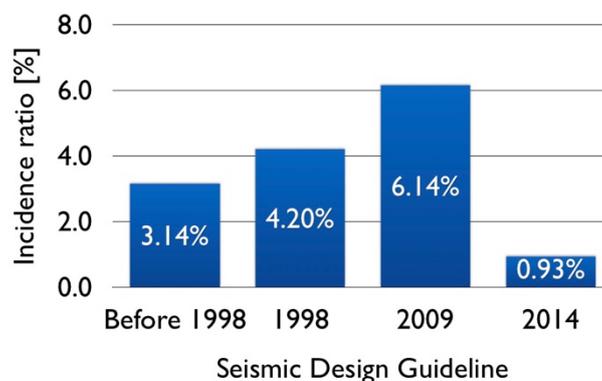
Figure 12 Relationship between edition of Seismic Design Guideline and incidence ratio of escalator (Kumamoto Earthquake in 2016)

Fig. 12 shows relationship between the edition of the Seismic Design Guideline and the incidence ratio. Although the incidence ratio of escalators after 2014 was small, the ratio increased with the edition. In order to clarify the reason of this result, an investigation in consideration of buildings is needed.

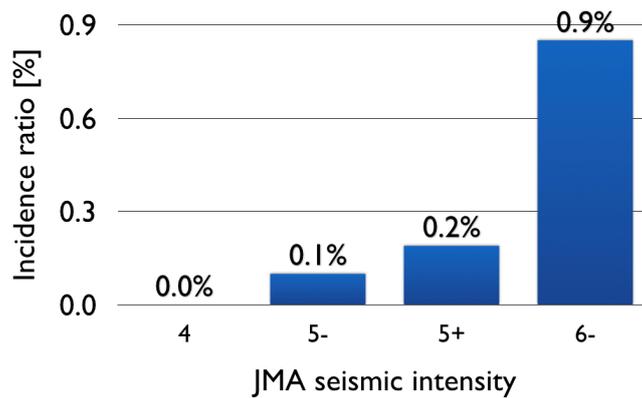
Figure 14 Relationship between JMA seismic intensity and incidence ratio of lift (North Osaka Earthquake in 2018)

Fig. 14 shows the incidence ratio by the JMA seismic intensity scale. As shown in Fig. 14, no damage of lifts occurred if the JMA seismic intensity was 4, and the incidence ratio became large if the JMA seismic intensity was 6-.

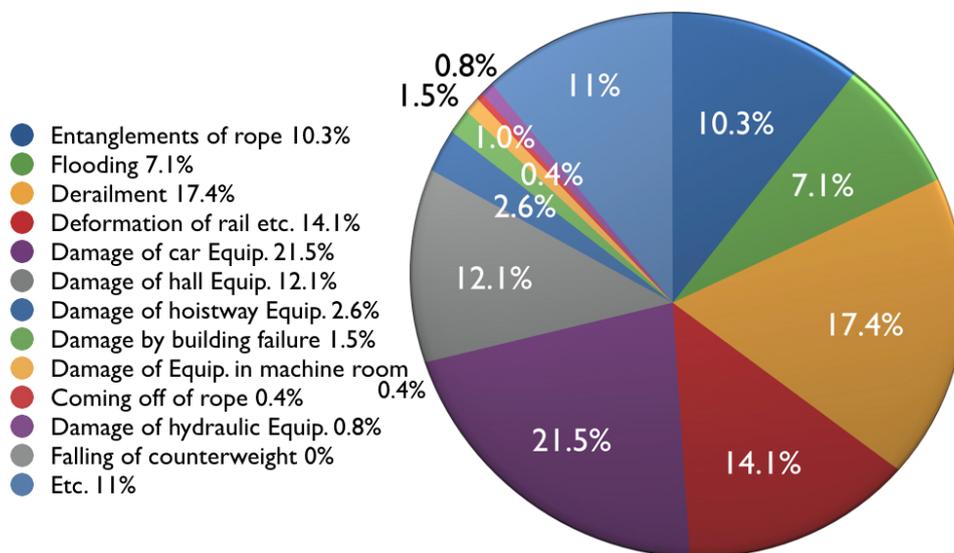
Figure 15 Damage of lift by cause (North Osaka Earthquake in 2018)

Fig. 15 shows damage of lift by cause. As shown in Fig. 15, ratio of derailments and damage of car equipment are large compared with other earthquakes. This damage was mainly occurred in lifts designed with the Seismic Design Guidelines issued in 1998 or before. On the other hand, damage by flooding was small because the earthquake was the near-field earthquake and tsunami didn't occur. Entanglements were also smaller than other earthquakes, because the scale of the earthquake was small as shown in Fig. 13. In other words, the maximum response displacement spectrum with damping ratio of 1% was less than 0.2 m, predominant period is small, and the duration time is so short that ropes didn't resonate.

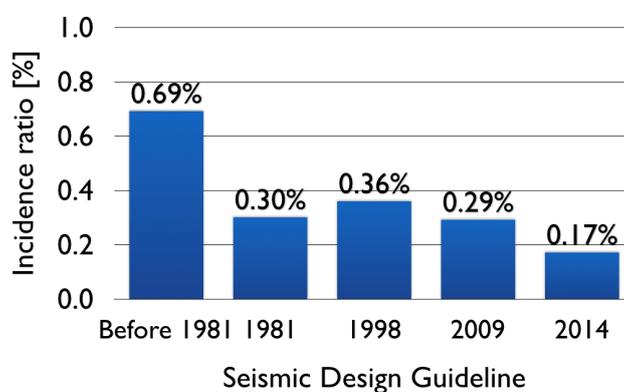
Figure 16 Relationship between edition of Seismic Design Guideline and incidence ratio of lift (North Osaka Earthquake in 2018)

Fig. 16 shows relationship between edition of the Seismic Design Guideline and the incidence ratio. Since the incidence ratio decreased with the edition as well as the Great East Japan Earthquake and the Kumamoto Earthquake, the revision seems to have been effective.

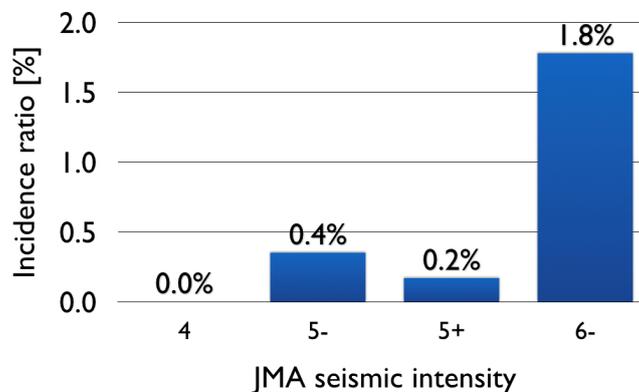
Figure 17 Relationship between JMA seismic intensity and incidence ratio of escalator (North Osaka Earthquake in 2018)

Fig. 17 shows the incidence ratio by the JMA seismic intensity scale. As shown in Fig. 17, no damage of escalator occurred if the JMA seismic intensity was 4, and the incidence ratio became large if the JMA seismic intensity was 6-. This tendency was same as the damage of lifts.

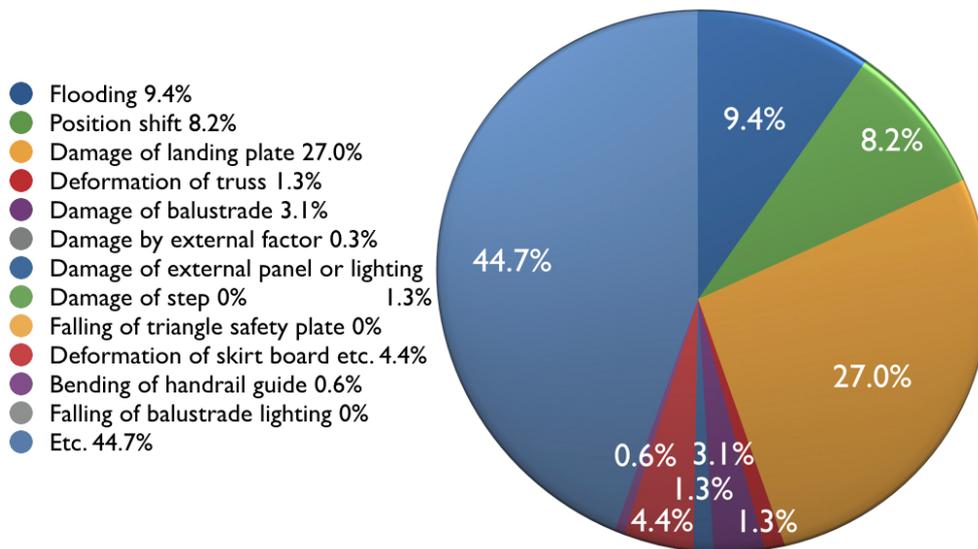
Figure 18 Damage of escalator by cause (North Osaka Earthquake in 2018)

Fig. 18 shows damage of escalators by cause. As shown in Fig. 18, damage of landing plates was remarkable. The landing plates are one of the boundaries between building structures. Thus, the response and interaction with building structures should be considered to reduce the damage of the landing plates. In addition, Etc. accounted for 44.7% of total damage, so the detailed investigations and revisions of the contents of the questionnaire should be considered.

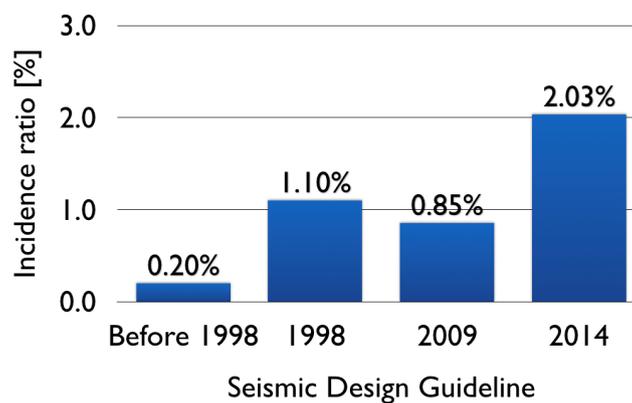
Figure 19 Relationship between edition of Seismic Design Guideline and incidence ratio of escalator (North Osaka Earthquake in 2018)

Fig. 19 shows relationship between the edition of the Seismic Design Guideline and the incidence ratio. The incidence ratio somehow increased with the edition as well as the damage by the Kumamoto Earthquake. As stated above, damage of escalators mostly occurred in boundaries with building structures. Therefore, this tendency should be evaluated from the viewpoint of both escalators and buildings.
