Report on Seismic Damage of Lifts and Escalators by Large Earthquakes in Japan

Satoshi Fujita¹, Motoo Shimoaki² and Keisuke Minagawa³

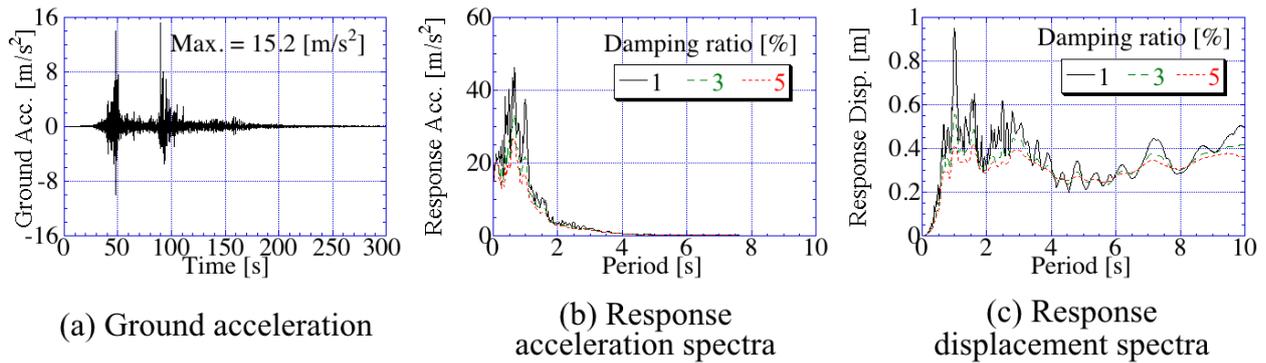
Figure 2 Ground motion observed in Sendai city (K-NET Sendai NS wave)

Fig. 2 shows the characteristics of the ground motion observed in Sendai city, 170km away from the epicenter. Sendai is the main city in Tohoku district, and its population is more than 1,000,000. The plural strong ground motions attacked Sendai city over long time as shown in Fig. 1.

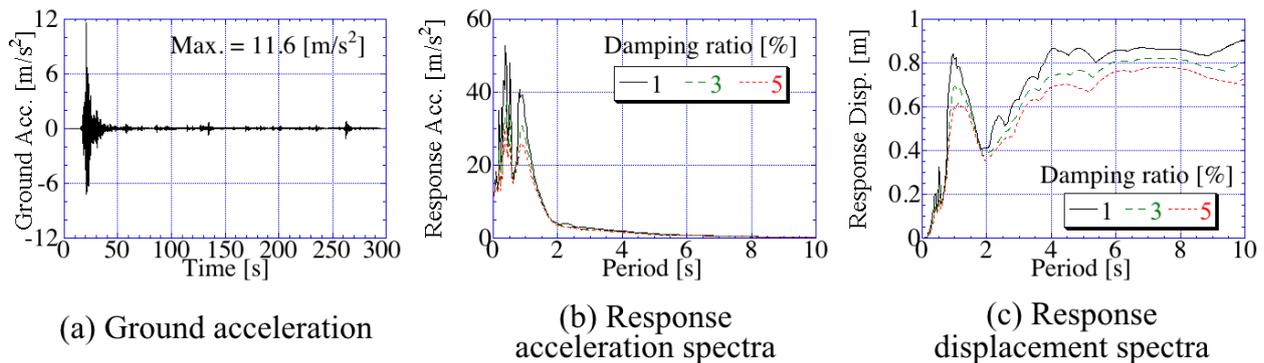
Figure 8 Ground motion observed in Mashiki town (KiK-NET Mashiki EW wave)

Fig. 8 shows the characteristics of the ground motion of the main shock that was observed in Mashiki town, 7 km away from the epicenter. Strong ground motion was observed as shown in Fig. 8. In addition, the duration time was long despite the near-field earthquake, and the response displacement spectra was large compared with other earthquakes.

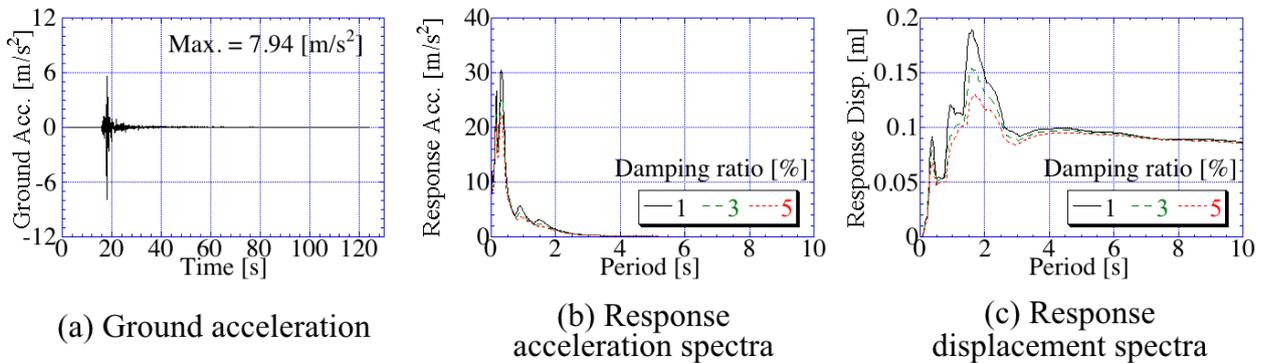
Figure 13 Ground motion observed in Takatsuki city (K-NET Takatsuki EW wave)

Fig. 13 shows the characteristics of the ground motion observed in Takatsuki city, 3 km away from the epicenter. As shown in Fig. 13, the maximum acceleration, duration time and spectra were smaller than the Great East Japan Earthquake and the Kumamoto Earthquake.
